# A REVIEW ON THE POSITION OF NURUOSMANIYE MOSQUE IN OTTOMAN ARCHITECTURE AND ITS LAST RESTORATION

GUNES, Z. Sena

## Restoration Process

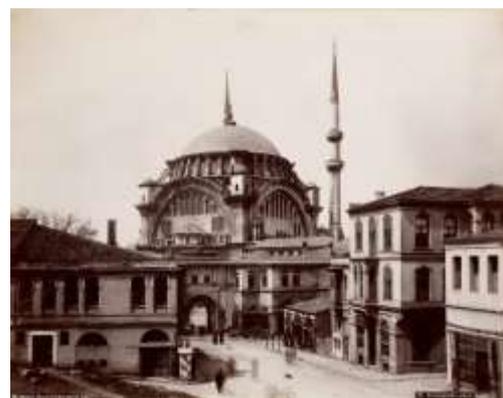
Figure 2: Mosque (Kargopoulo, 1875)

Likewise the structure of the mosque is a unique structure for Ottoman architecture. The structural system designed with marble – known as a soft stone – and inner iron bars to support masonry system. The iron parts of Nuruosmaniye Mosque is not an independent structure itself. However this creates a complex masonry desing. In this regard, the significance of the Nuruosmaniye Mosque comes from not only the ornaments in a mixed Ottoman-Baroque style but also its layout and constructional system.

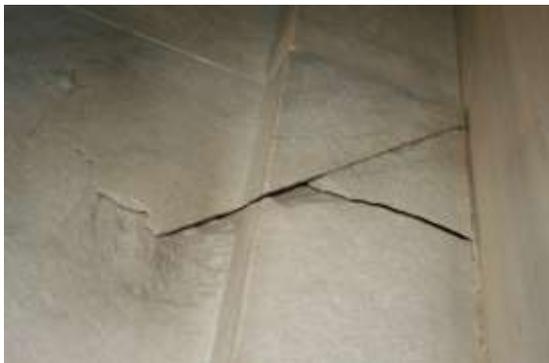
Figure 3: Corrosion based marble crack (Güneş, 2011).

The building consists of marble and iron. Effects of upper level and lower level humidity caused deteriorations on and in this building materials. Because of corrosion of inner iron materials, deep cracks were occured on the stones of the walls. Managing this cracks included both iron and stone (marble mostly) applications. Interventions for iron applied in two ways: changing the material with new one or conserving the existing. Combining cracked stone parts was not possible thus cracked stones were removed by a decay method and replaced with stones which had similar characteristics with original.

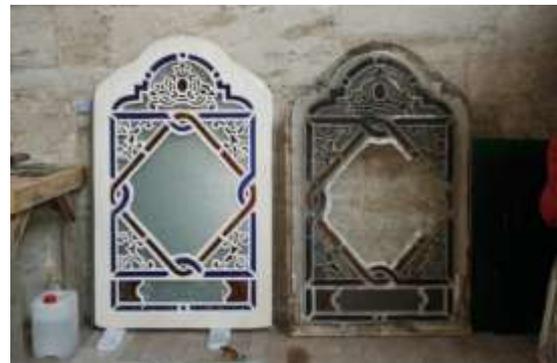
Figure 4: Revzen window renovation (Güneş, 2011).

Environmental pollution caused blackening on the facades. The facades of the mosque were cleaned with two methods: sandblasting and cleaning with water. Sandblasting technique were used for most of the surfaces with proper pressure and diluted solutions were used for dirtier surfaces such as minarets. Dry cleaning was preferred rather than wet cleaning for the high density of iron materials within the structure. Also environmental factors have negative mechanical effects on revzen windows. Unless the revzen windows could be repaired, reproducing method was chosen with the original decoration, shape and material as possible as the first day.

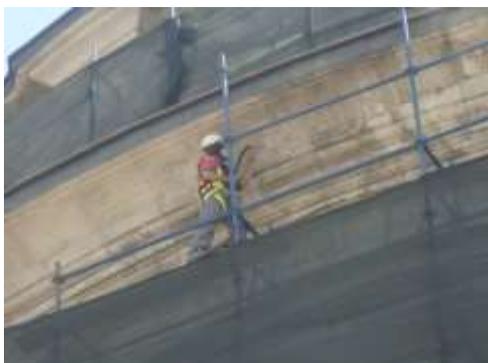
Figure 5: Sandblasting of facade (Güneş, 2011).

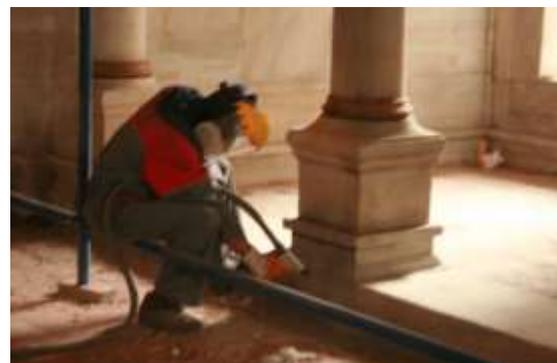
Figure 6: Interior sandblasting (Güneş, 2011).

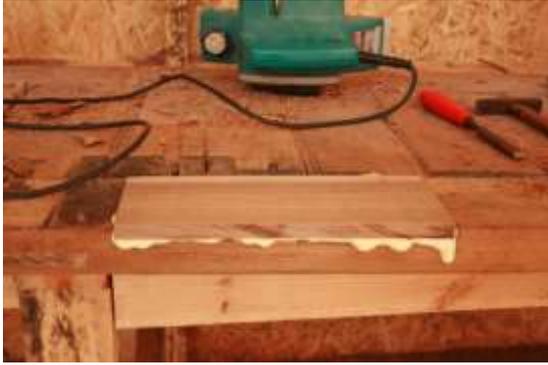
Figure 7: Integration of timber elements (Güneş, 2011).

The original door wings and original window shutters were made of walnut tree. This building elements were original. As a wrong conservation application, the timber elements were painted with oil-paint which cleaned by chemical techniques. After cleaning, only the highly deteriorated parts of timber elements were cut and integrated with original material. Fumigation applied to prevent timber elements from insects and as the last step shellac polish (which is a traditional polish with organic contend) was used for a long-term conservation.

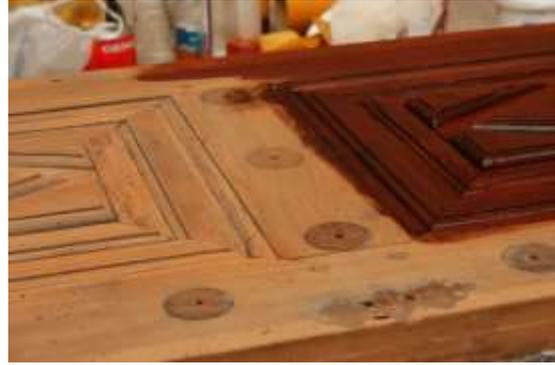
Figure 8: Applying shellac polish (Güneş, 2011).

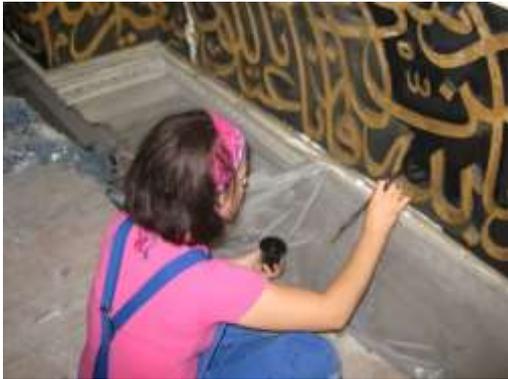
Figure 9: Restoration of ornaments (Güneş, 2011).

Nuruosmaniye Mosque has laminar hand-drawn ornaments. However, the ratio of hand-drawn ornaments were low according to Classical Ottoman mosques. Besides, the belt of verse (Fetih Sura) which is written with gold on black surface is rare and was deteriorated by humidity. While the belt was repairing, the scraping of hand-drawn ornaments were continuing. During the scraping process of ornaments, earlier ornaments were found. Scientific council of the Nuruosmaniye Mosque decided to display the authentic hand-drawn ornaments and leave a segment of latter ornaments to give reference to guests.

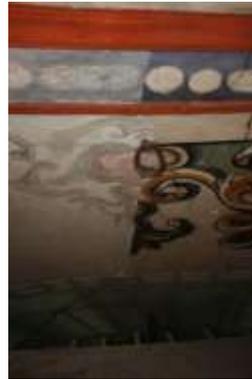
Figure 10: Scraping and foundings (Güneş, 2011).
